MC56F81xxx_0N91Z

Mask Set Errata

Mask Set Errata for Mask 0N91Z

This report applies to mask 0N91Z for these products:

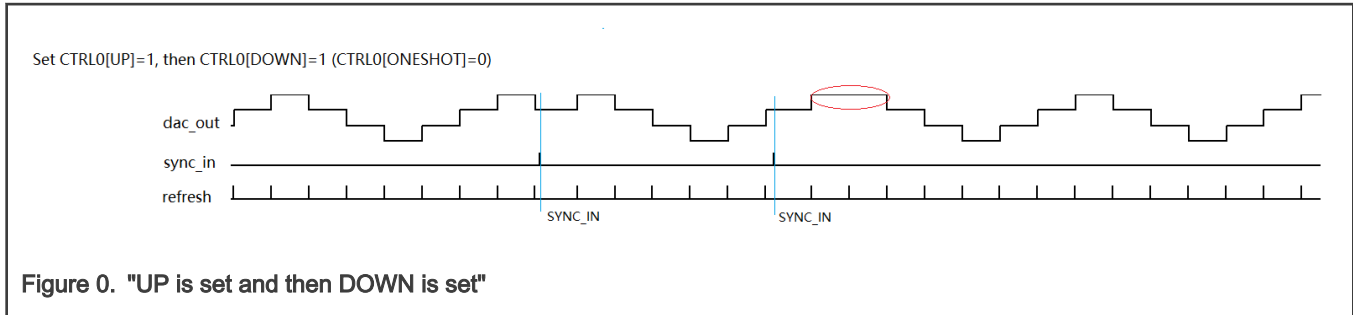
ERR051706: The DAC output jumps to MAXVAL or MINVAL value and lasts two REFRESH clock cycles (instead of one) in the first waveform period after an active SYNC_IN signal occurs with CTRL0[ONESHOT]=0 and CTRL0[AUTO]=1 in triangle waveform mode

1. When CTRL0[UP] is set first, then CTRL0[DOWN] is set in the initialization: DAC output goes down first and then goes up. If an active SYNC_IN signal occurs when DAC output is ramping up, DAC output by design is set to the updated MAXVAL value and a new periodic triangle waveform is generated. In this situation, at the beginning of the first waveform period after SYNC_IN signal occurs, DAC output stays at updated MAXVAL for two REFRESH clock cycles instead of one. There's no such issue if an active SYNC_IN signal occurs when DAC output is ramping down in this case. See the illustration below.

No workaround.

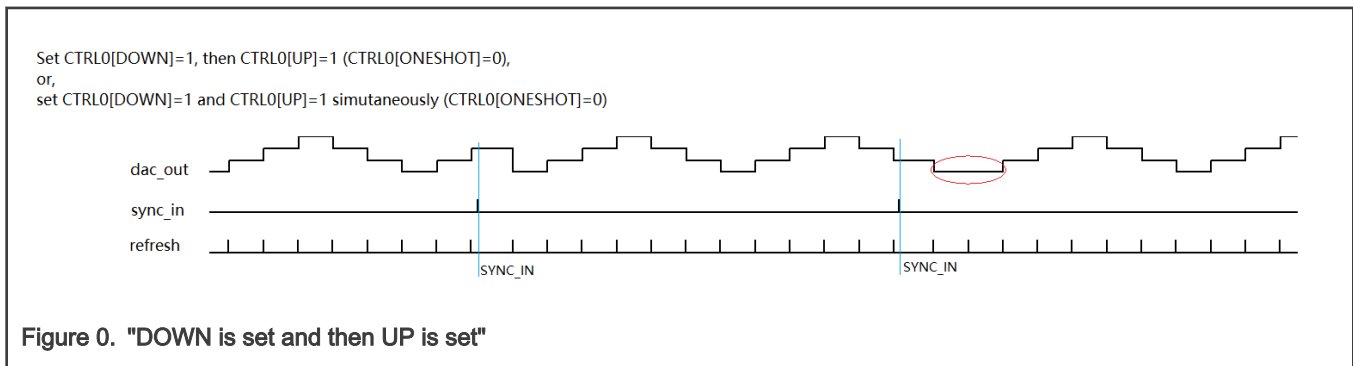
2. When CTRL0[DOWN] is set first, then CTRL0[UP] is set (or DOWN and UP are set simultaneously) in the initialization: DAC output goes up first and then goes down. If an active SYNC_IN signal occurs when DAC output is ramping down, DAC output by design is set to the updated MINVAL value and a new periodic triangle waveform is generated. In this situation, at the beginning of the first waveform period after SYNC_IN signal occurs, DAC output stays at updated MINVAL for two REFRESH clock cycles instead of one. There's no such issue if an active SYNC_IN signal occurs when DAC output is ramping up in this case. See the illustration below.
