Document Number: MM912_637ER

Rev. 4.0, 14 Jan 2020

MM912_637, Silicon Mask Errata

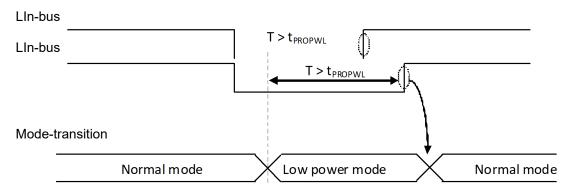
Figure 2. Unwanted LIN Wake-up Behavior from Low Power mOde

However, if the LIN module is enabled and if the LIN bus is in a dominant state during the transition from Normal to Low Power mode, the LIN module will wake up on the next rising edge of the LIN bus, assuming that the duration between mode transition to rising edge is greater than the bus wake-up deglitcher (t_{PROPWL} , typical 80 μ s). This scenario is depicted on the next graph.

When LIN is enabled before transition to Low Power mode, and if the LIN is in a dominant state, then due to a timing issue in the circuitry, the LIN switches to Low Power mode after the rest of the device. Under this condition, an unexpected falling edge on the RCV line occurs, leading to an unwanted wake-up condition.

The LIN software must ensure that the LIN module is disabled before a transition to Low Power mode. In this case, the unwanted wake-up from low power is no longer present.

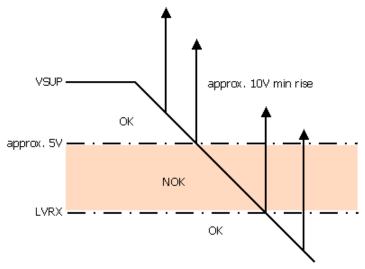
Figure 3. Transient Signal Shape

During a specific transient on V_{SUP} , V_{DDX} will generate an overshoot that will exceed the V_{DDX} Max Rating. The overshoot will only occur if the transient signal on V_{SUP} meets the conditions below:

- V_{SUP} is initially at a level low enough to cause V_{DDX} to be in a low drop out condition (i.e. V_{SUP} below approximately 5.0 V and over LVRX)
- 2. From this level, V_{SUP} increases by approximately 10 V with a rise time faster than a few microseconds.

As shown in Figure 3, if the V_{SUP} transient occurs for levels of V_{SUP} > the V_{DDX} dropout voltage or V_{SUP} < V_{LVRX} (the Low Voltage Reset level), the V_{DDX} overshoot will not occur.

While V_{SUP} rises according to above conditions, the V_{DDX} regulator will switch from low drop out mode to regulated mode. This transition will last several microseconds and may lead to an overshoot on V_{DDX} .

To ensure V_{DDX} remains within its Max Ratings, it is recommended to add the following RC filter on VSUP (pin 21), as shown in Figure 4:

Minimum RC filter time constant = 47 μ s

Recommended RC filter= 10 Ω and 4.7 μ F (minimum value for the decoupling capacitor, according to datasheet)
