Mask Set Errata for Mask 1L31R

This mask set errata applies to the mask 1L31R for these products:

- MC9S08GB60
- MC9S08GT60
- MC9S08GB32
- MC9S08GT32
- MC9S08GT16

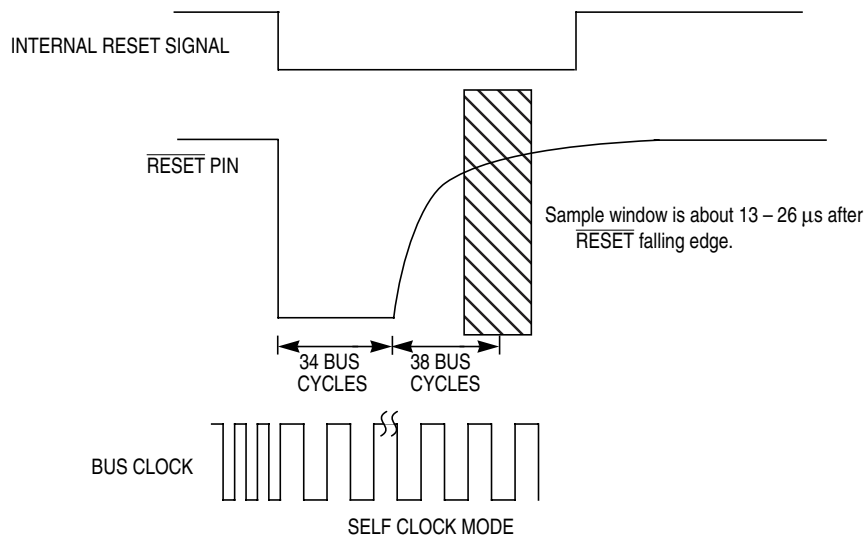
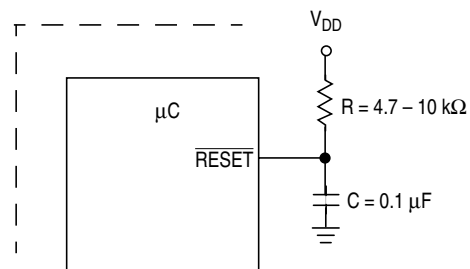
Figure 1. HCS08 SIM Reset Lockup

HCS08 with ICG — Falling Edge on $\overline{\text{RESET}}$ During Termination of Reset Events

If a falling edge is detected on the external reset pin at either of two sample points, the MCU will cease operation and will recover only after a power-on reset.

Case 1 — After detecting a reset signal, either internal or external, the internal reset circuit latches the cause of the reset, forces a low level on the external $\overline{\text{RESET}}$ pin for about 34 bus cycles, releases the pin, and samples the pin level about 38 bus cycles later. The ICG will revert to self-clock mode (SCM) at the beginning of the reset cycle. Therefore, the first sample window is about 13 μs to 26 μs after the initial reset signal, due to the frequency range and characteristics of the internal oscillator.

Case 2 — After remaining in reset for an extended period of time due to an externally applied low level on $\overline{\text{RESET}}$, the internal reset circuit will sample the pin level about 9 to 10 bus cycles after the pin raises above its V_{IH} level. The ICG will revert to self-clock mode (SCM) during reset. Therefore, the second sample window is about 1.7 μs to 3.6 μs after the reset signal rises above V_{IH} , due to the frequency range and characteristics of the internal oscillator.

Workaround — Case 1

To avoid multiple edges on the $\overline{\text{RESET}}$ pin due to switch contact ringing or EMC noise, eliminate any voltage bounce through RC filtering. A 0.1 μF capacitor to ground and an external 4.7 k Ω to 10 k Ω resistor to V_{DD} works well to ensure noise suppression.

Workaround — Case 2

In addition to RC filtering, avoid spurious edges on the $\overline{\text{RESET}}$ pin caused by external active circuitry such as low voltage detectors and watchdog components. Do this by ensuring that external circuitry cannot drive $\overline{\text{RESET}}$ low within 10 bus cycles of the release of $\overline{\text{RESET}}$.
